SERVICE MEMORANDUM

13 April 1959

DISTRIBUTOR CLAMPING

MGA TWIN-CAM

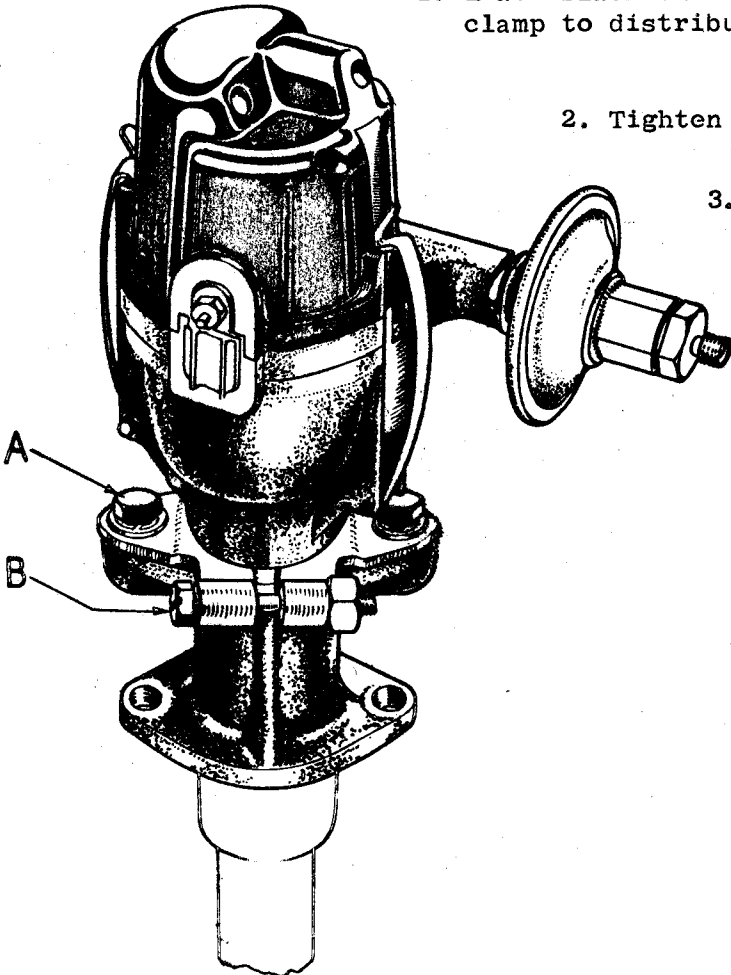
Excessive wear of the distributor driving gears is indicative of misalignment of the distributor with its drive, causing stiffness and consequent excessive loading of the gears.

This misalignment is due to incorrect tightening of the distributor clamp. The proper sequence of operations is as follows:

1. Leave slack the two bolts 'A', holding clamp to distributor drive housing.
2. Tighten clamping screw 'B'.
3. Give engine a few turns to ensure correct alignment.
4. Finally tighten the two bolts 'A'.
