BMC Mini-Cooper
Saab
Triumph Herald 1200
MGA
Sunbeam Alpine

**CHOICE
CAR SUPPLEMENT**

OCTOBER 1962

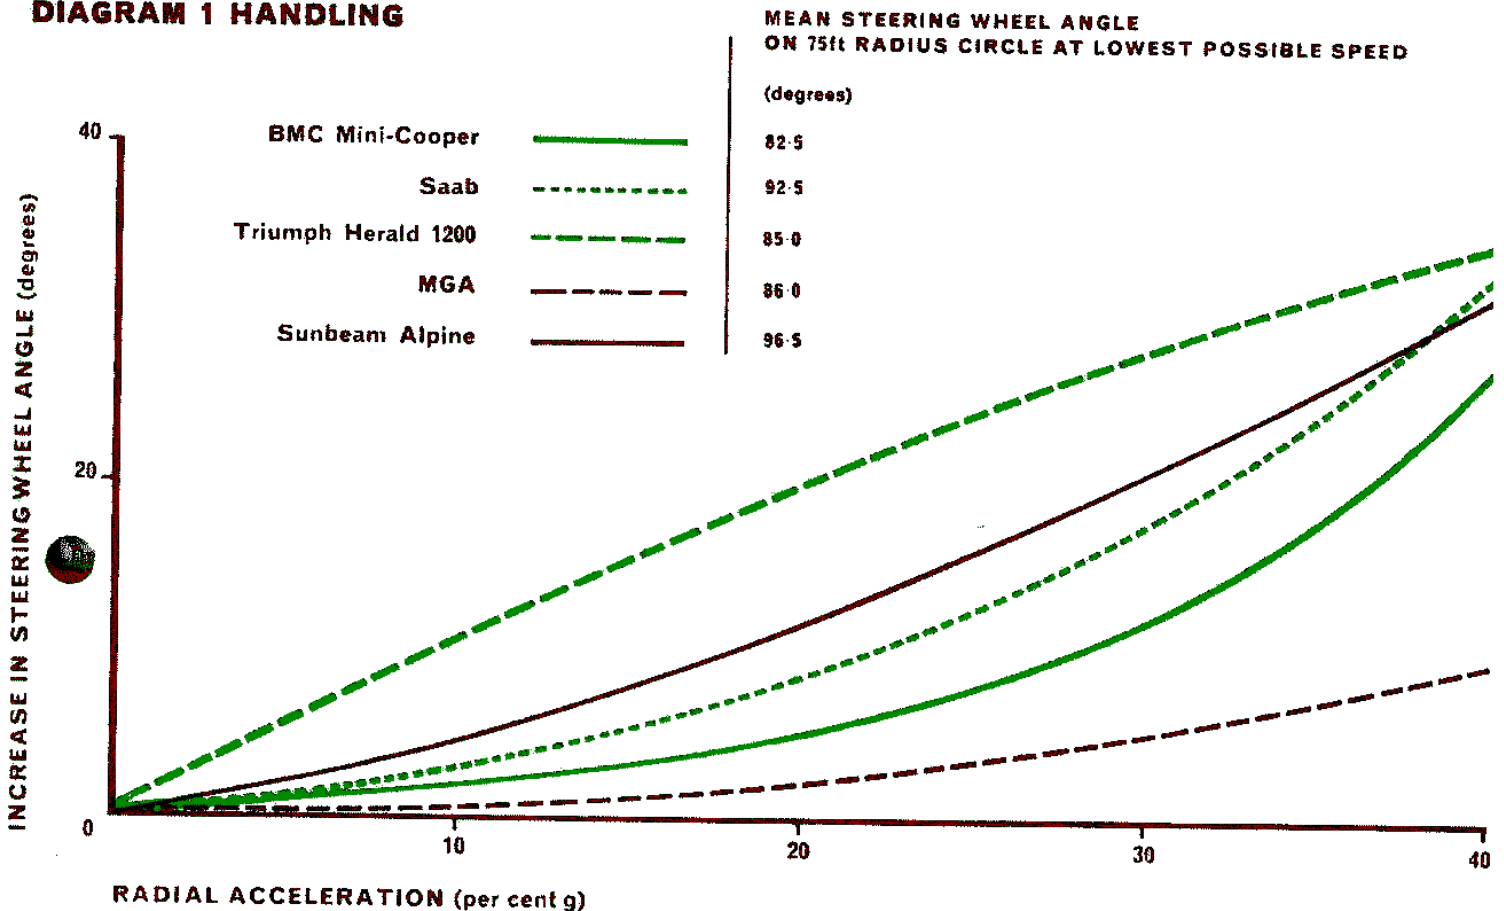
DIAGRAM 1 HANDLING

With more ruthless cornering, understeering became more and more marked—that is, as the speed increased, the driver had to turn the steering wheel more and more to keep the car on the same curve. This is represented by the line on the graph going upwards. Characteristically, it was the front tyres which broke away first. This happened particularly when the road was slippery or the front tyres were worn. Since the car wore out its front tyres quickly it is as well to pay constant attention to them. In general it was safe and sure in its handling.

The graph shows that the SUNBEAM ALPINE had marked understeering tendencies, and our drivers did not like its handling nearly as well

as the MGA's. Its handling was described as 'mushy' and our drivers said that it tended to 'wallow' in corners. This understeering meant that the driver—if he cornered fast—had a considerable amount of hard work to do on the steering wheel.

Our objective test was to drive the cars round a 75 ft radius circle at increasing speed, having first found the amount the steering wheel had to be turned to keep the car on the 75 ft radius curve, going as slowly as possible. The results, including the amount the steering wheel had to be turned, are in Diagram 1, expressed in terms of the increase in steering wheel angle for different radial accelerations, measured in terms of g (the acceleration caused by gravity—32.2 ft/sec/sec).

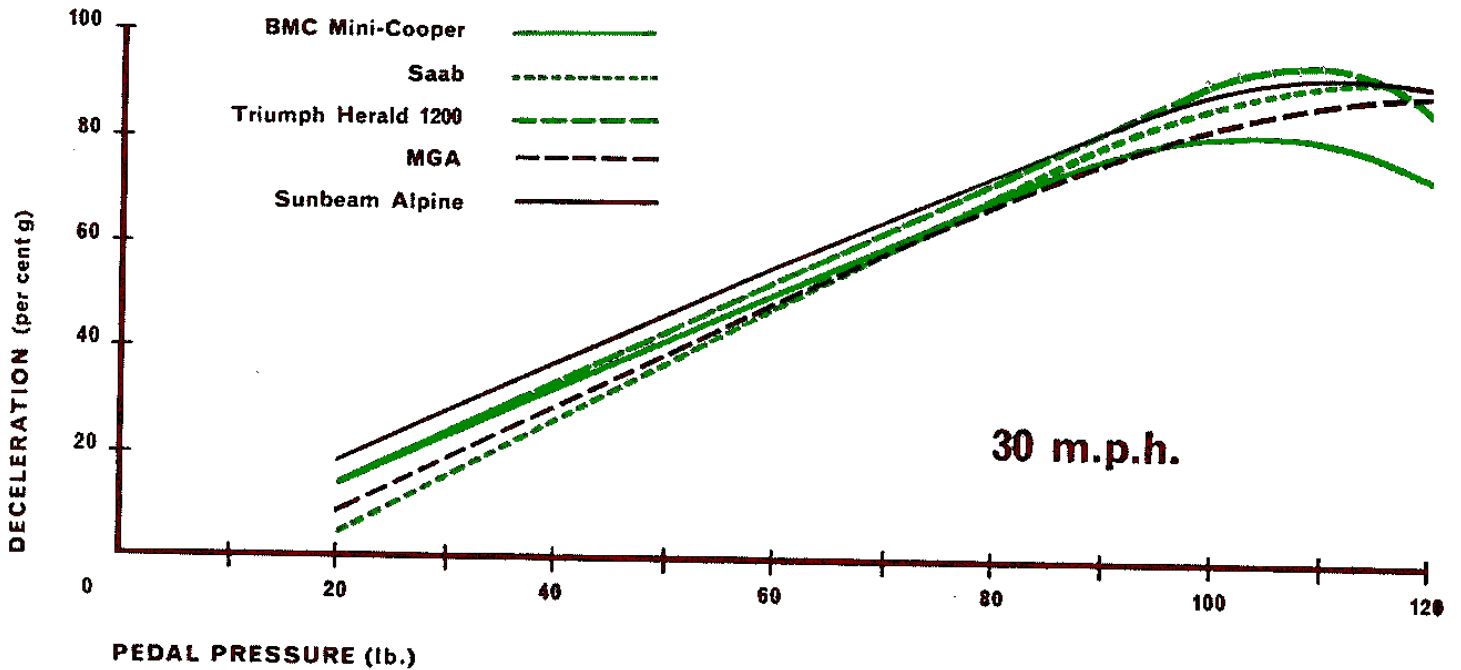
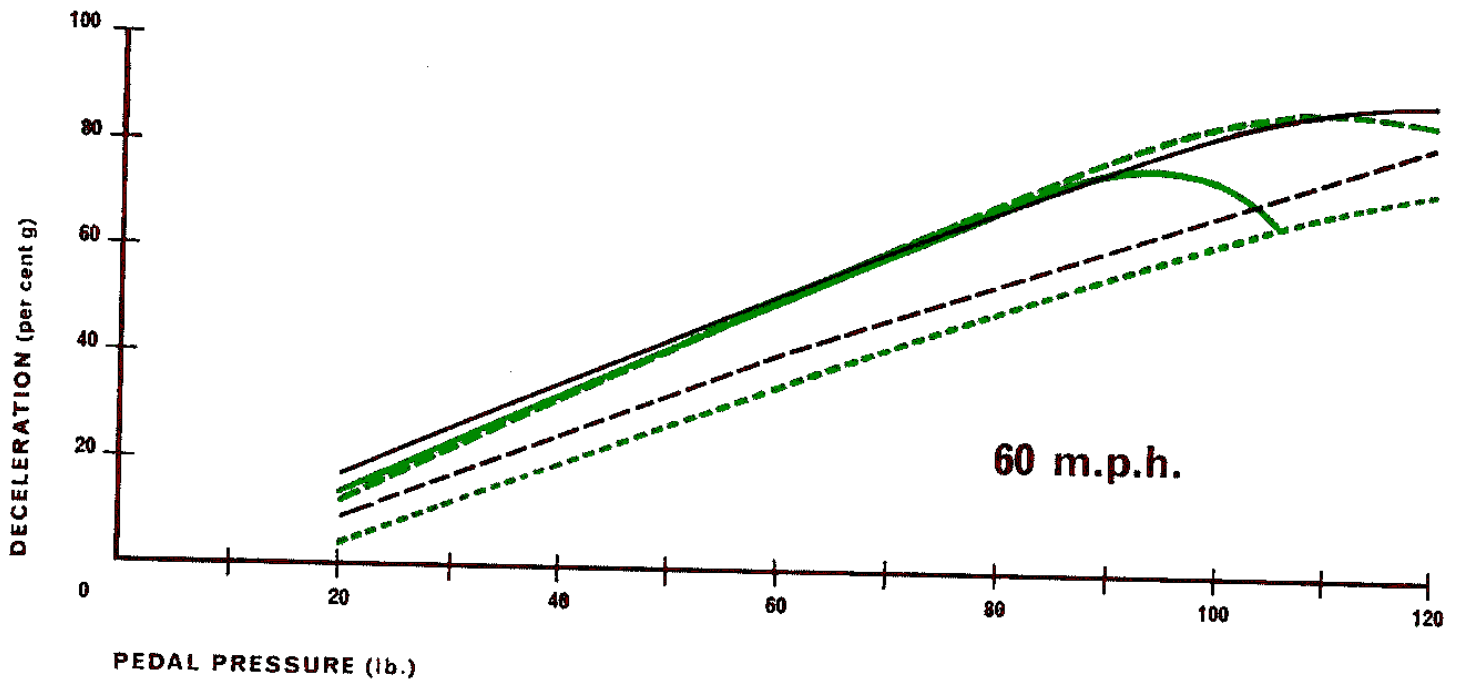
DIAGRAM 3 BRAKING

Of the two sports cars, the SUNBEAM ALPINE was more satisfactory, stops at both 30 and 60

mph needing very similar efforts. The MGA needed heavier pressures. Neither car could match the braking performance of the **FORD CONSUL 375** (see June 1962 Car Supplement). As they can go much faster, this is a pity.

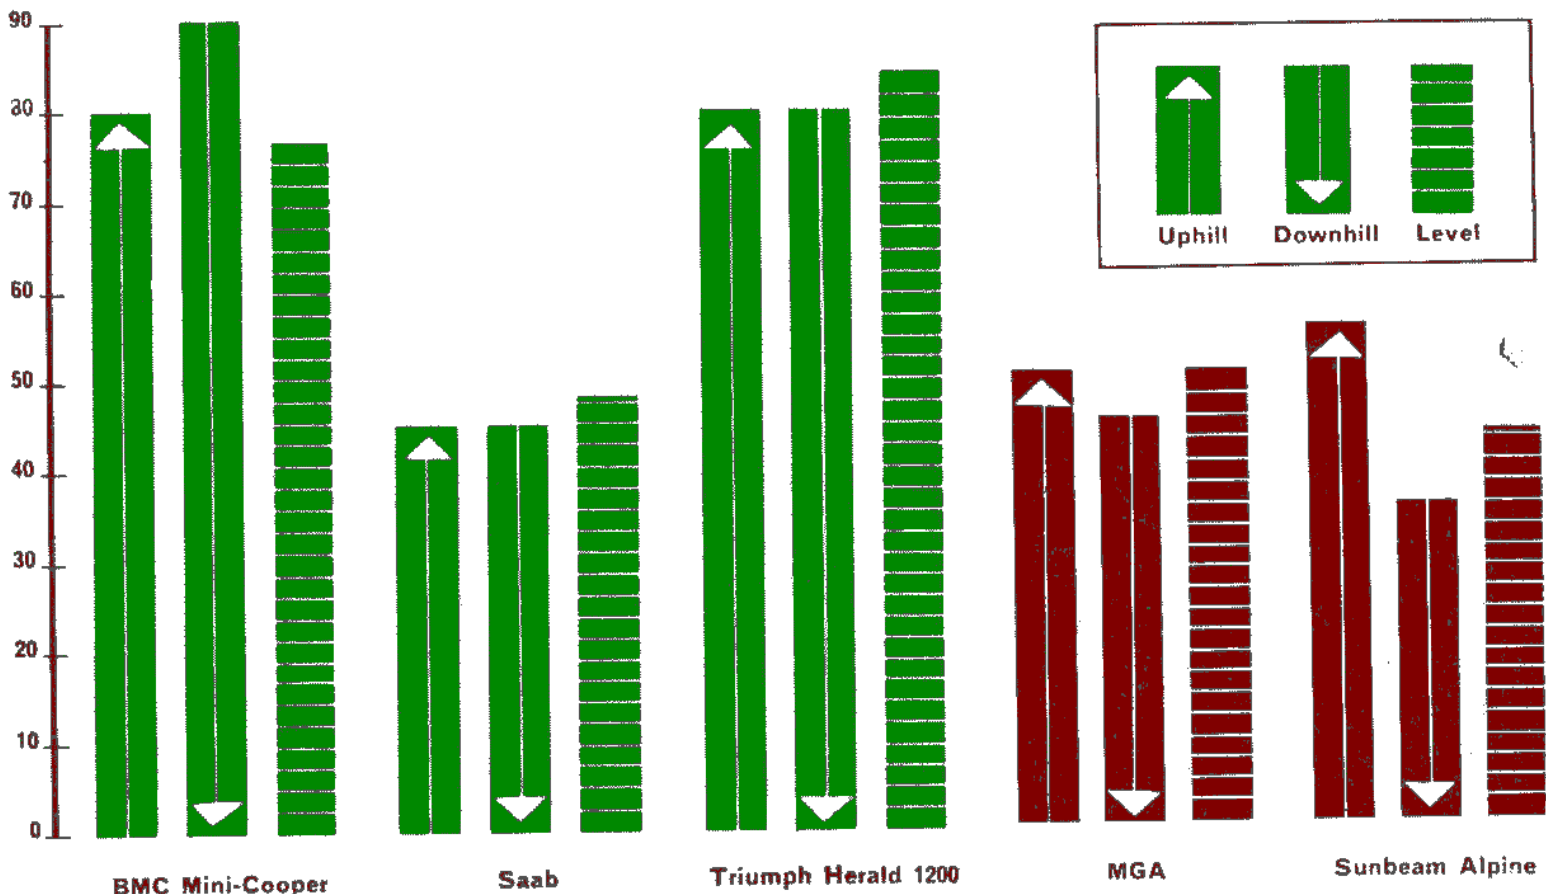
DIAGRAM 4 HAND BRAKE (pull required in lb.)

The **SUNBEAM ALPINE** lost slightly less effectiveness than the **MGA** initially and recovered in 20 minutes to the **MGA**'s 30 minutes.

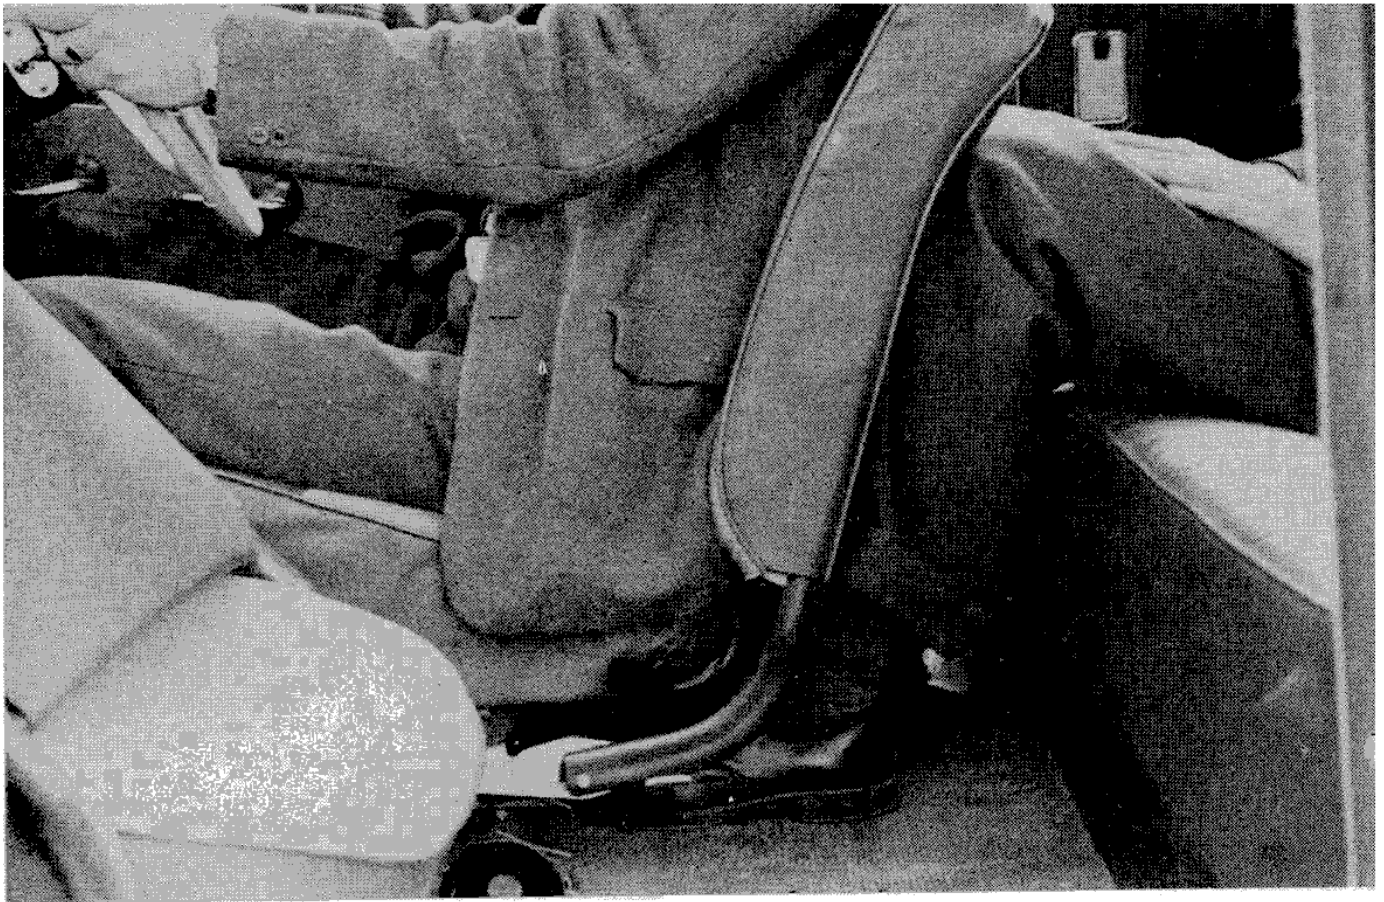
Limited knee room in Saab back seat, with front seat right back

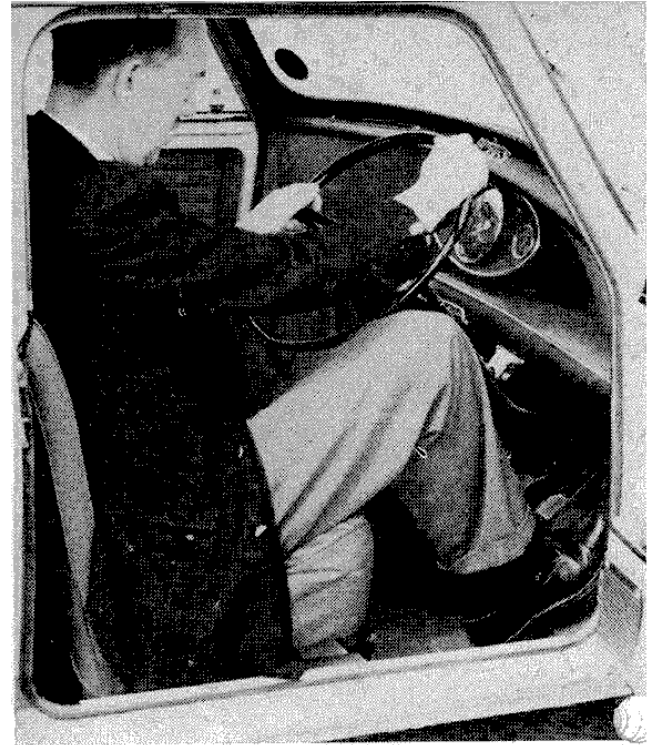
Uncomfortable posture for tall driver in BMC Mini-Cooper

Of the three saloon cars, the BMC MINI-COOPER was the least comfortable. Most of our drivers found the seat squab too upright. The adjustment backwards was completely inadequate for taller drivers, and indeed, to make life tolerable for them, we had to modify the

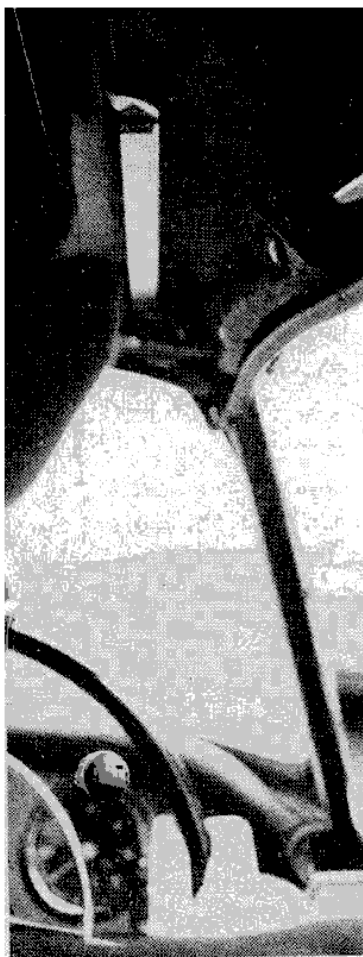
*Hazards to heads:
Hood irons in
Sunbeam Alpine*

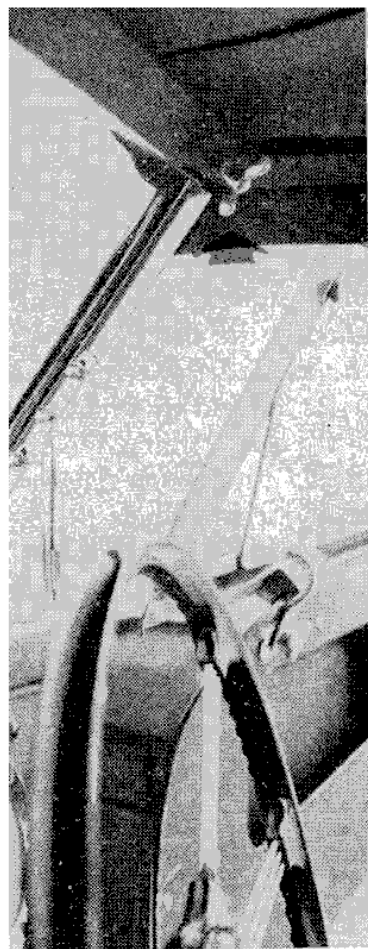
Hood screw in MGA

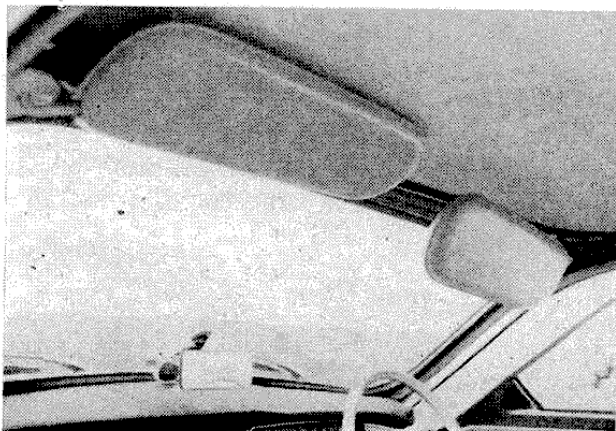
Large, padded sun visors in Saab

The SAAB had large sun visors, which would adjust to the side. Our drivers liked them. In

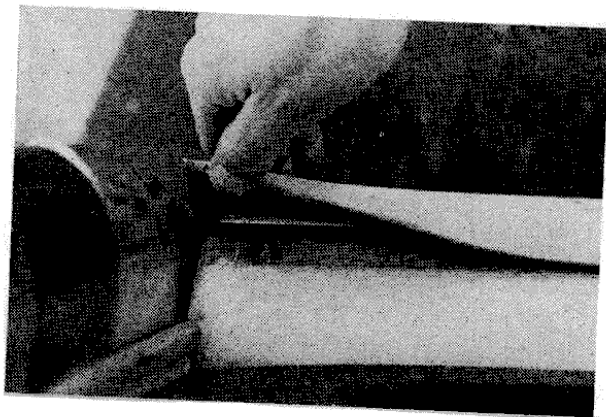
Rubber coming off Triumph Herald 1200 bumper

The bumpers on the TRIUMPH HERALD 1200 consisted merely of a shaped part of the body panelling covered in white rubber.

Rubber-covered bumpers are in principle a good idea. Doctors who have studied the injuries inflicted by motor cars on pedestrians have suggested that rubber-covered bumpers might help to make the injuries less severe. It also seems sensible to make bumpers of a material which does not corrode after being damaged. Although the TRIUMPH HERALD 1200's bumpers were rubber-covered, the furthest projections at both front and back were, in fact, the overriders which were chrome-covered. This removed most of the advantages of covering the bumpers with rubber. Moreover the rubber was inclined to come away from the bumper.

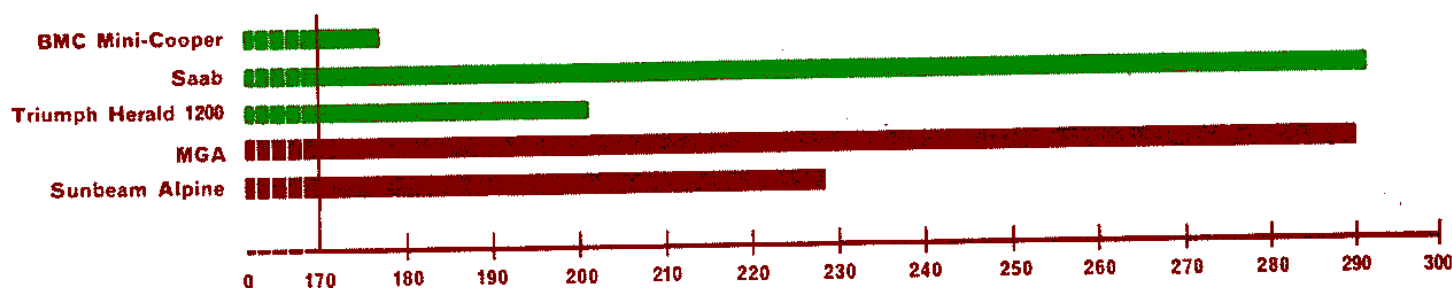
DIAGRAM 5
PETROL TANK
mileage available from full tank

Diagram 5 shows the cars' range on a full tank of petrol at our overall petrol consumption. The SAAB had much the longest range of the saloons; the MGA the longer of the sports cars.

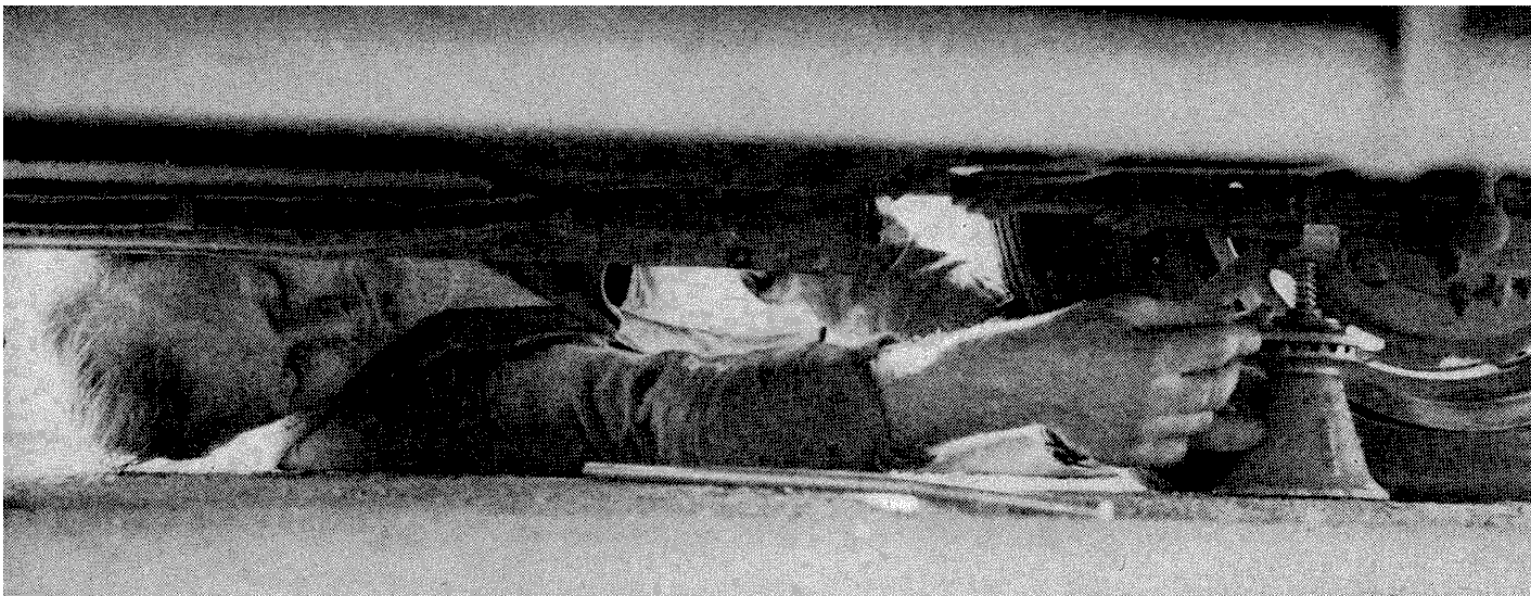
Putting the MGA jack into position

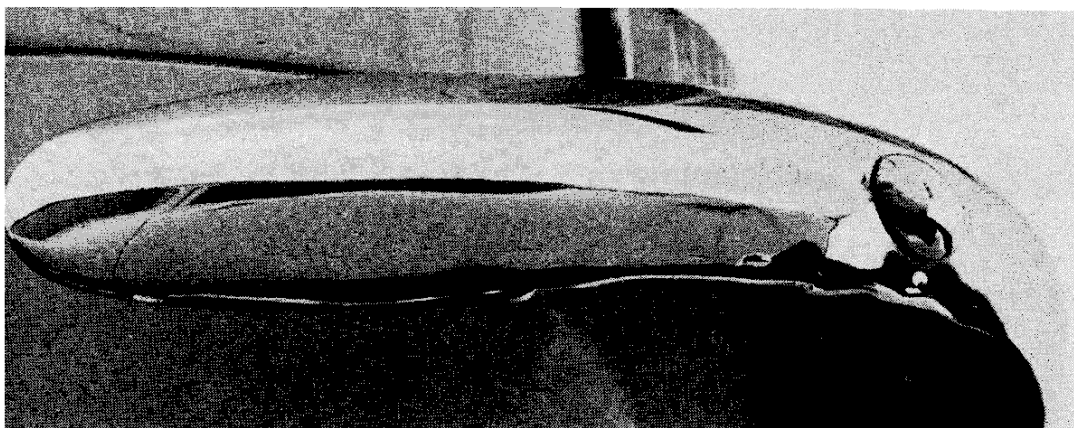
Ragged bottom edge of Sunbeam Alpine bumper

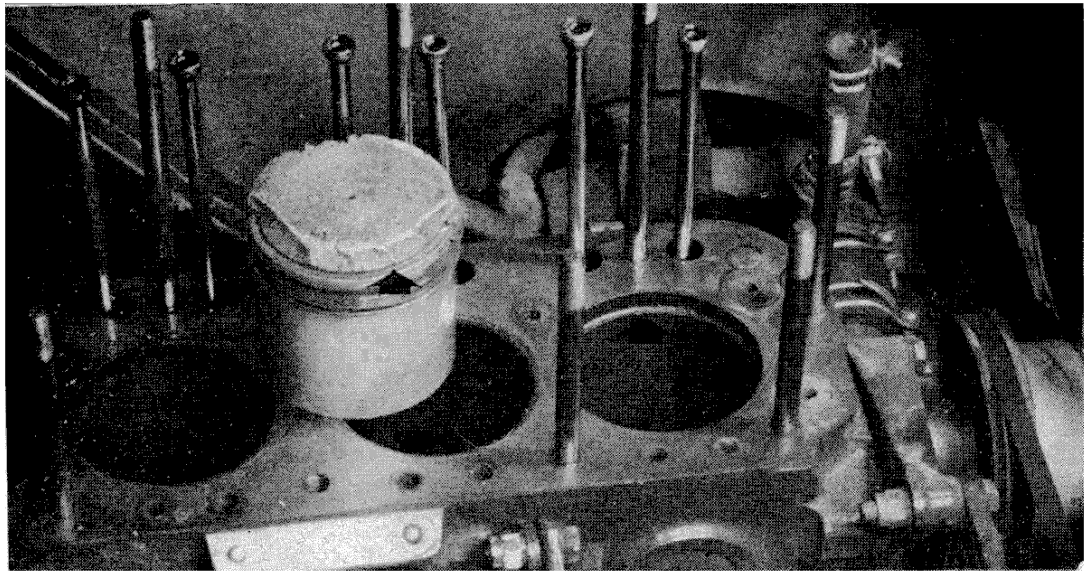
MGA engine failure: Cylinder liner dropped; piston crown damaged

The MGA suffered two disasters: a major engine failure and the movement of the brake disc pads in their carriers. Although both were very serious, and clearly should not have occurred, we would ascribe them to poor workmanship rather than bad design, and so they would not necessarily recur in other samples. Apart from this the car came through the tests very well.

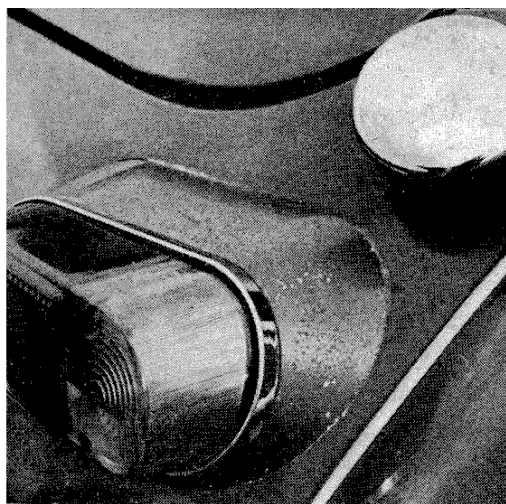
Paint coming off MGA below petrol filler cap
