MG / 394 cancelling MG/365

SERVICE MEMORANDUM

HOOD SEALING

MGA 1600

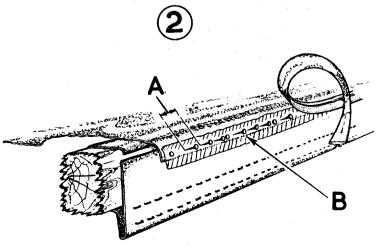
When water is found to be entering the car over the front hood stick, the following method of sealing is recommended.

- 1. Carefully remove the double-cord piping concealing the canopy tacks (Fig. 1)
- S
- 2. Increase the number of tacks securing the hood canopy to give a spacing of approximately $\frac{1}{2}$ " (12.5 mm.) as at "A" (Fig. 2).

- 3. Brush on a suitable adhesive over the canopy seam $\frac{1}{2}$ " (12.5 mm.) wide as at ${}^{\dagger}B^{\dagger}$.
- 4. Take a strip of P.V.C. leathercloth material, ½" (12.5 mm.) wide, the length of hood stick and firmly seal down with adhesive directly over tacks and seams as at "B".
- 5. Replace double-cord piping.
